University of South Australia

Coastal Settlements Adaptation Study

Stage 1: State of Play

October 2013

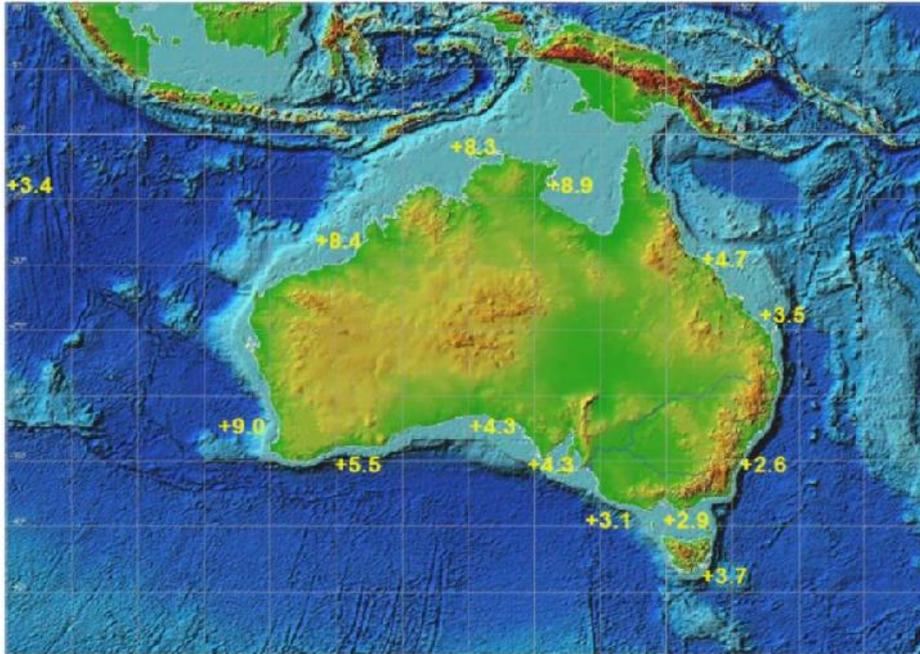
Figure 3 – Sophisticated gauges at Thevernard and Pt Stanvac have recorded an average of 4.3mm per year since 1990 (Bureau of Meteorology, 2013)

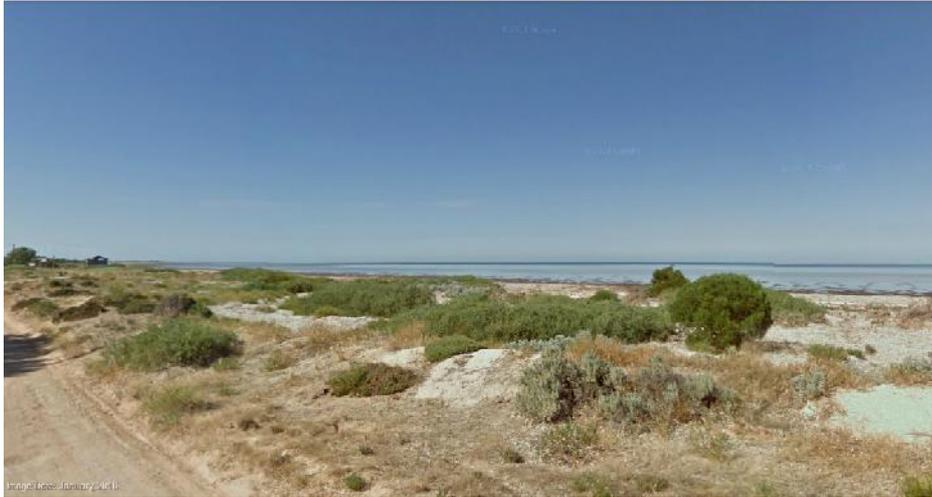
Figure 7: Foreshore Parham (North) (Google Maps, 11.08.13)

- The Esplanade Road is at a height in this location of approximately 2.20m AHD to 2.5m AHD.
- Protection from the west is provided by a dune having a maximum height of 2.4m to 2.7m between Main Street and North Terrace, and a little higher between Main and First Street at 2.8m to 3.0m. Points are noted on the map where the dune may be lower. The levee is sparsely vegetated (See Figure 7)

- A rubble levee was constructed along the front in the 1960s and Peter Zeider used a front end loader to build up the levee on the southern end of Parham and between First Street and Main Street subsequent to the flood event of 4th July 2007.

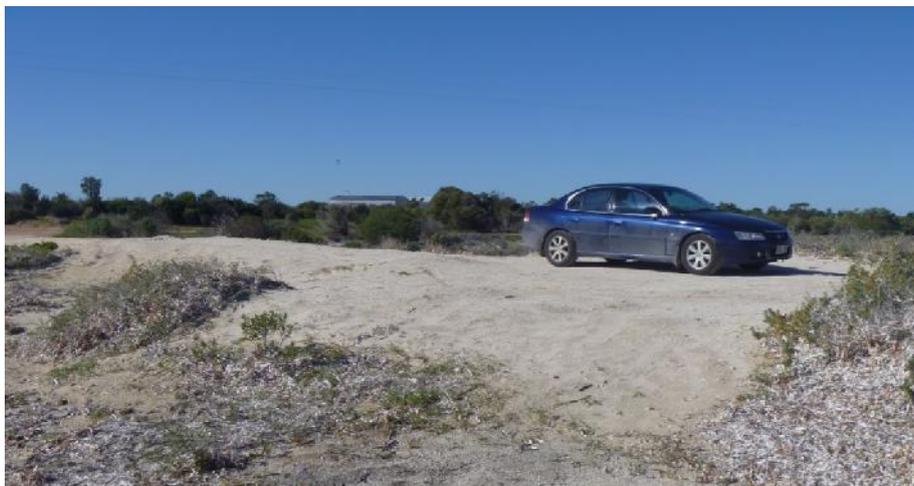
Figure 11: Shell grit levee on northern end of Esplanade (Photo: M. Western, 2013)

- A shell grit levee to approximately 1m high (and at 2.80m AHD approx) was installed between the dune and the Esplanade to halt any future sea water moving south. There have been no further incidents since 2009 (Figure 11). Work was installed in an emergency mode but no retrospective development approval was obtained. Input from residents suggest that this may have been a replacement of a levee rather than a new installation.

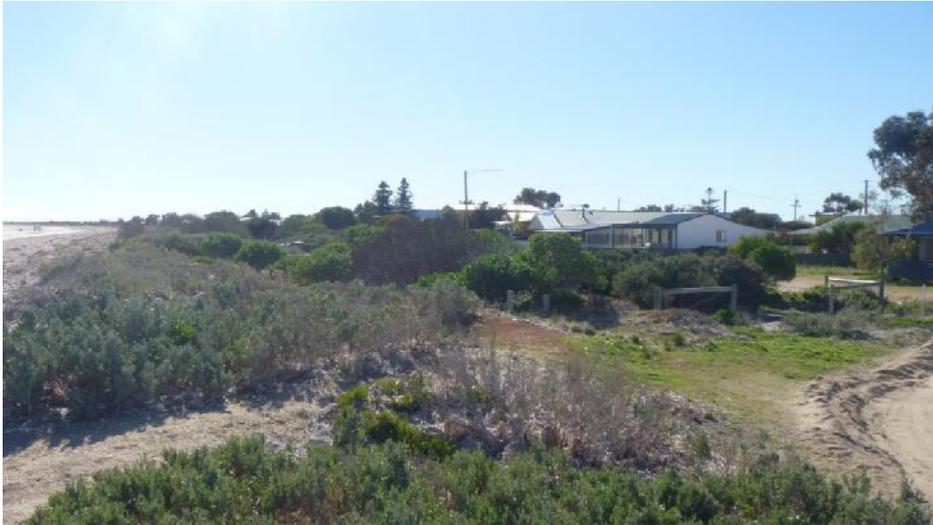
Figure 14: Well-vegetated dune on southern end of Esplanade (M. Western, 2013)

- Protection from the west is provided by a dune having a maximum height of 2.7m to 3.0m. The green band of colour indicates where the dune is likely to be at height 3.0m or over but some sections of the dune are likely to be no higher than 2.4m (see *Map 1.b*). The dune is densely vegetated on the southern end and access is controlled by fencing. **The height of the sand dune was also raised on the southern end of Parham, presumably in 2007 (See Parham Map, Appendix 6 and Figure 14).**

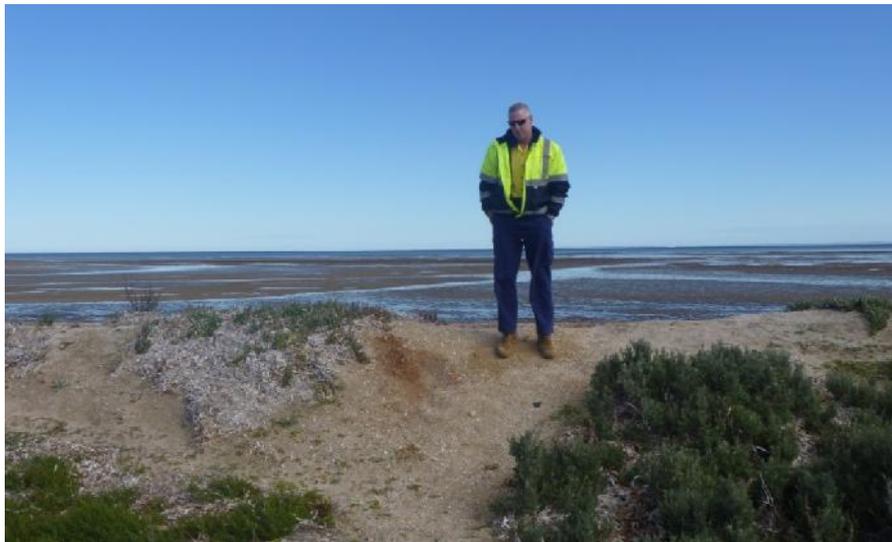
Figure 17: Location of break where water entered southern roundabout (M. Western, 2013)

- On 25th April, 2009, sea water broke through the shell grit levee on the roundabout at the southern end of Parham and travelled north along the Esplanade (Figure 17).

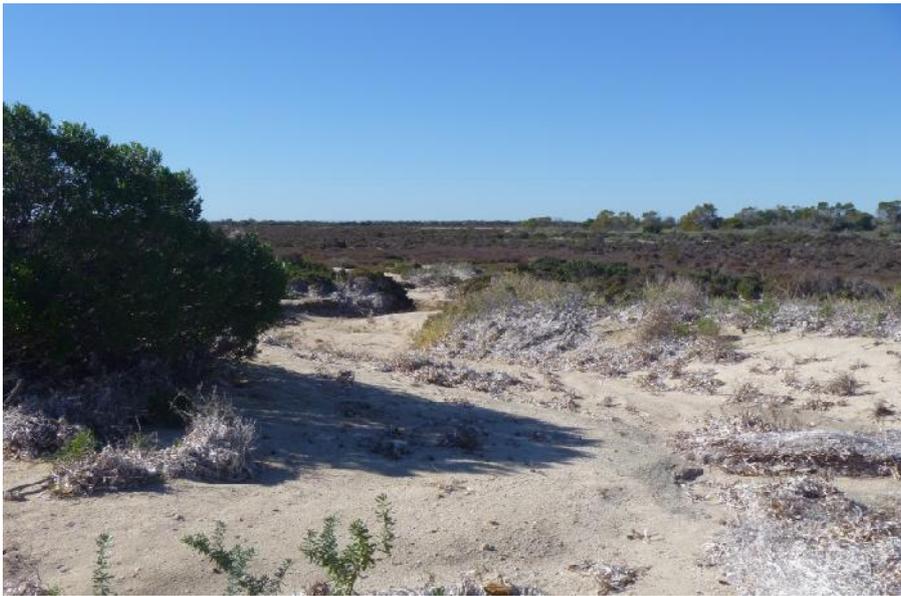
Figure 18: The tide broke through dune 50m south of Parham (M Western, 2013)

- On 25th April, 2009, the tide broke through the dune system about 50m to the south of the roundabout (Figure 18) and water travelled north-east alongside the shell grit levee. Water entered rabbit boroughs in the levee at the end of Prime Street and the levee collapsed allowing water to flow down Prime at low levels and no damage recorded (Figure 19). Water entered to the rear of two or three houses at the end of Prime Street (Source: K. Earl). On 25th April, 2009, with a south westerly storm, water broke through sand dunes to the south of Parham creating 'a new creek', eroded the levee and entered Prime Street. Water lay on the eastern side of Prime Street. Water also overtopped the levee/dune between First Street and Main Street and a 'small amount of water' came over the ramp at South Terrace (Figures 19a to 19d).

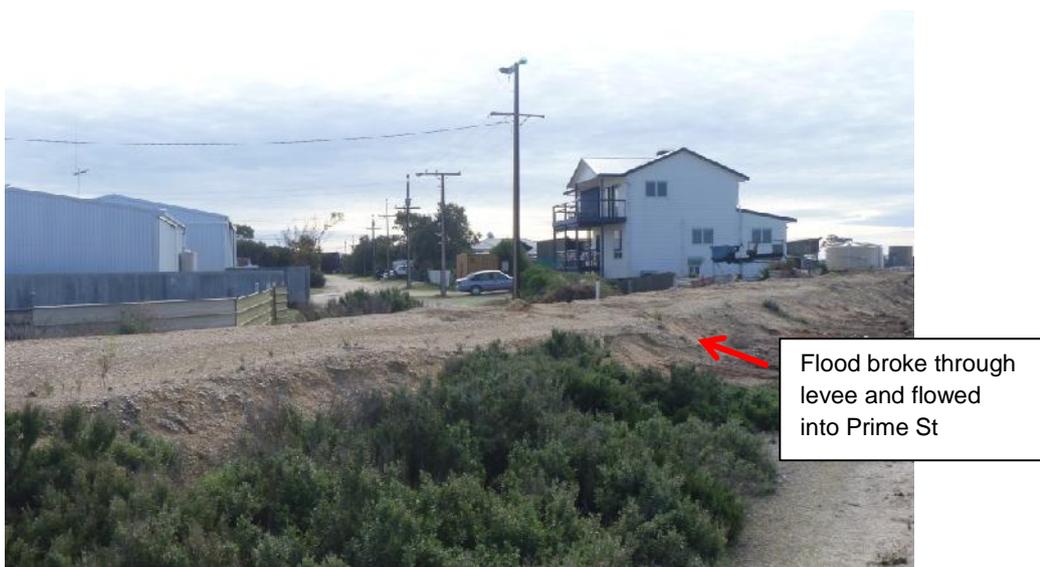
Figure 19: Water broke through levee weakened by rabbit boroughs (M. Western, 2013)

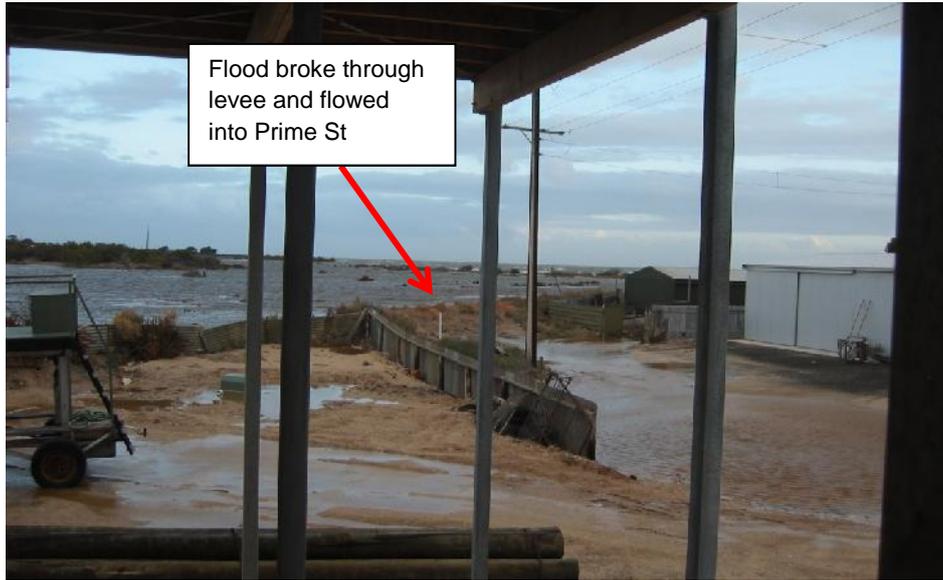
Flood broke through
levee and flowed
into Prime St

The levee in Figure 19a has since been upgraded (see Figure 21).

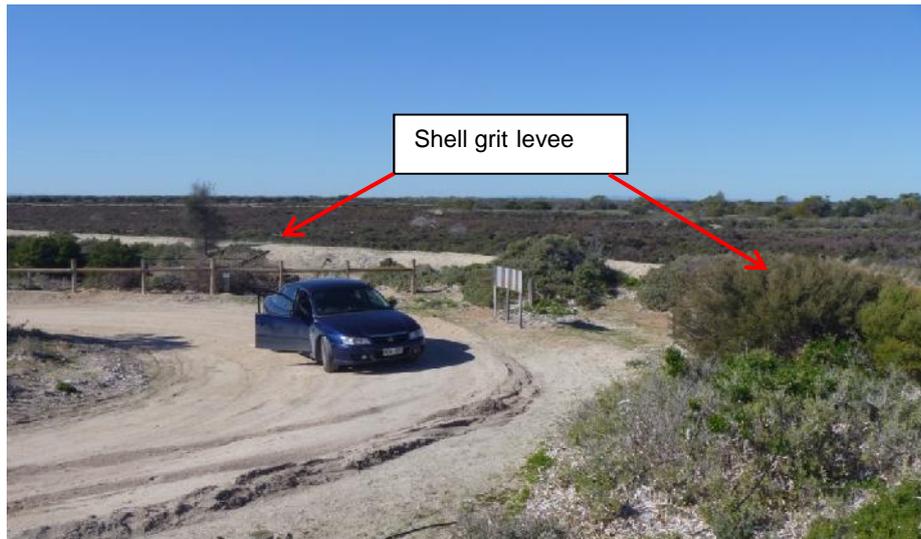
Figure 20: Shellgrit levee protects the roundabout and continues to east (M Western, 2013)

- A shell grit levee has been installed around the southern roundabout. However, this is only 1-3 metres thick and unlikely to withstand flood events. There is a significant height difference from the road (1.80m) within the roundabout to the top of the levee (3.0m approx.). The levee has no record of development approval. The shell grit levee at approx. 3.0m high continues from the roundabout around the rear of Parham (South) (Figure 20).

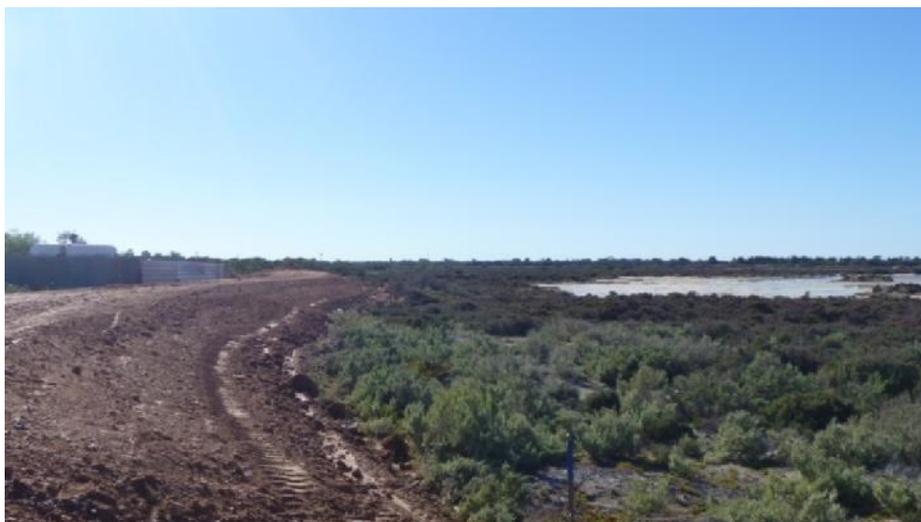
Figure 21: New clay levee installed to rear of Parham April 2013 (Mark Western, 2013)

- The second man-made protection work is a clay levee installed to the rear of Parham (South) in April 2013 at heights 3.25 to 3.15 AHD (Figure 21). Development approval was obtained.

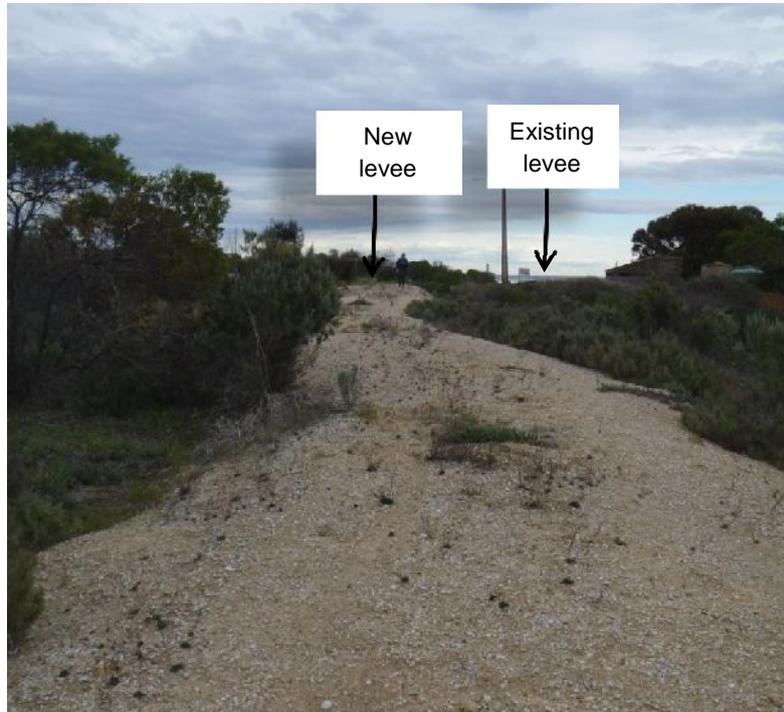
Figure 37: Levee installed in 2009 subsequent to flood event (Photo: M. Western, 2013)

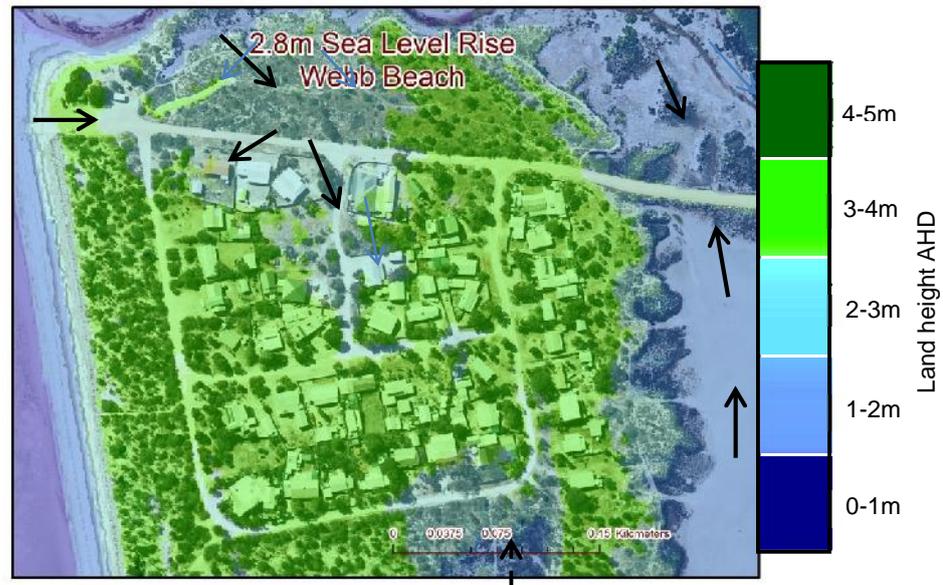
Figure 38: Possible impact of 2.8m AHD event if of significant duration

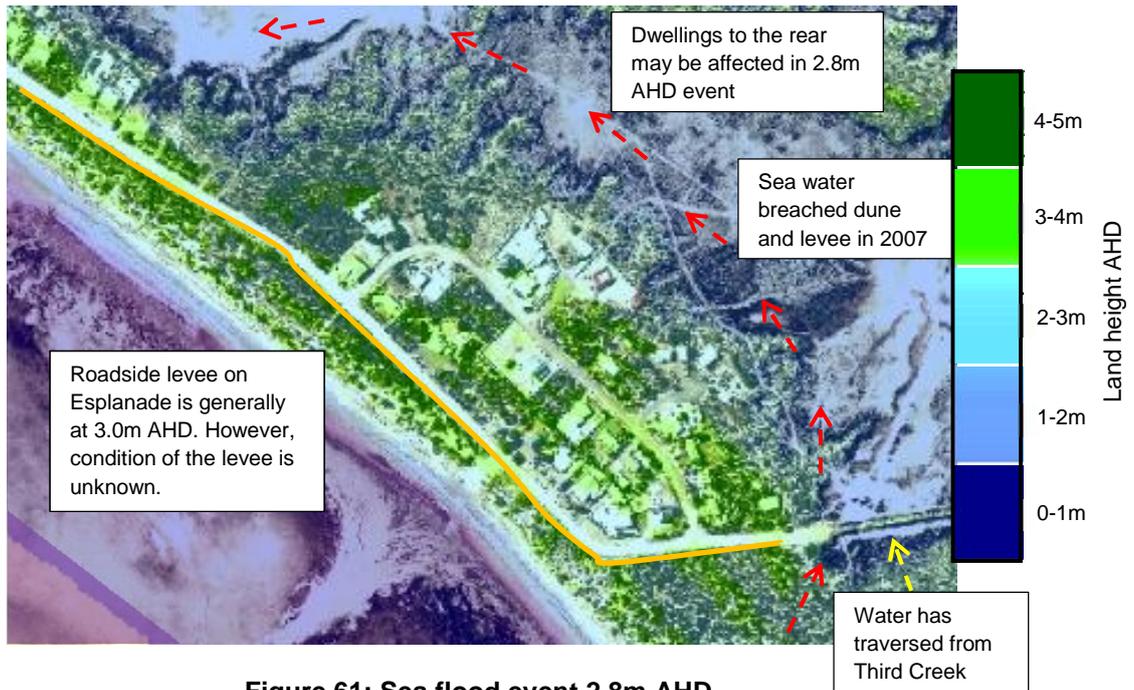
Figure 61: Sea flood event 2.8m AHD.

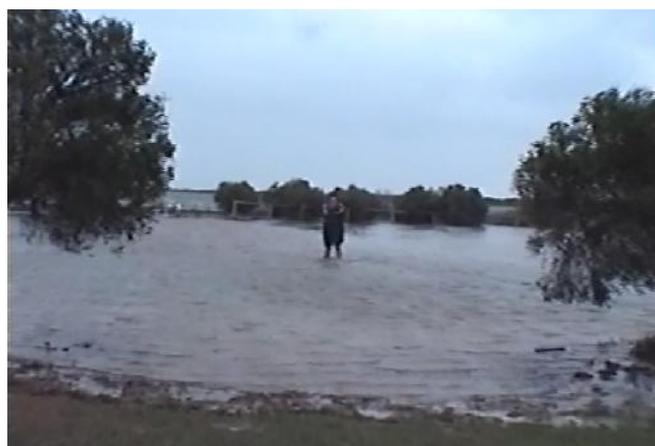
Figure 83: Markers such as these suggest the AHD height of the water was 2.4-2.5m (J.Kneuit,2007)

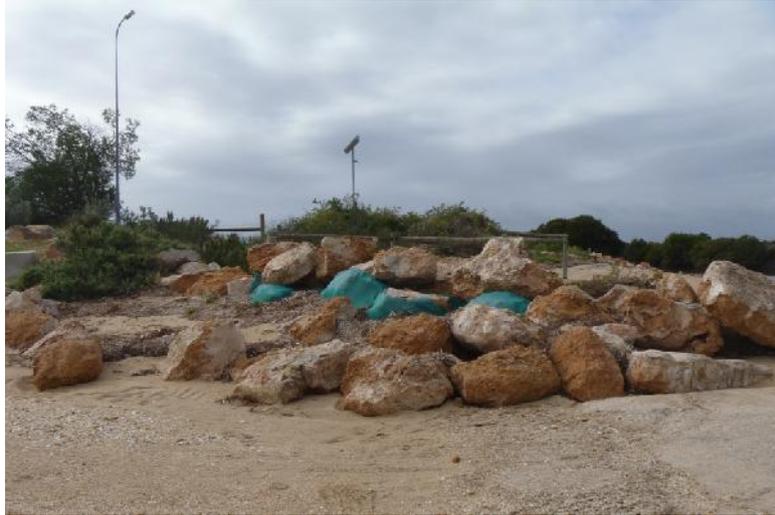
Figure 85: Rock armament to southern tip of settlement (M. Western, 2013).

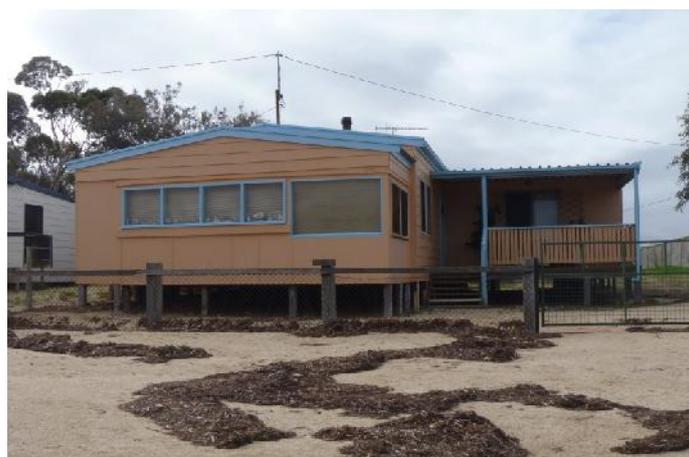
Figure 89: Elevated floor – stump foundation (M. Western, 2013)

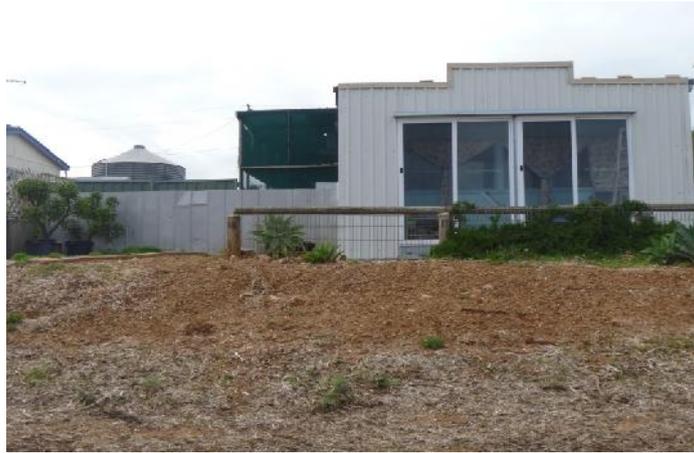
Figure 90: Earthen levee – common along the frontage at varying heights (M. Western, 2013).
